2002 Annual Compliance Report Gunnison, Colorado, Disposal Site

Figure 8-1. 2002 Annual Compliance Drawing for the Gunnison, Colorado, Disposal Site

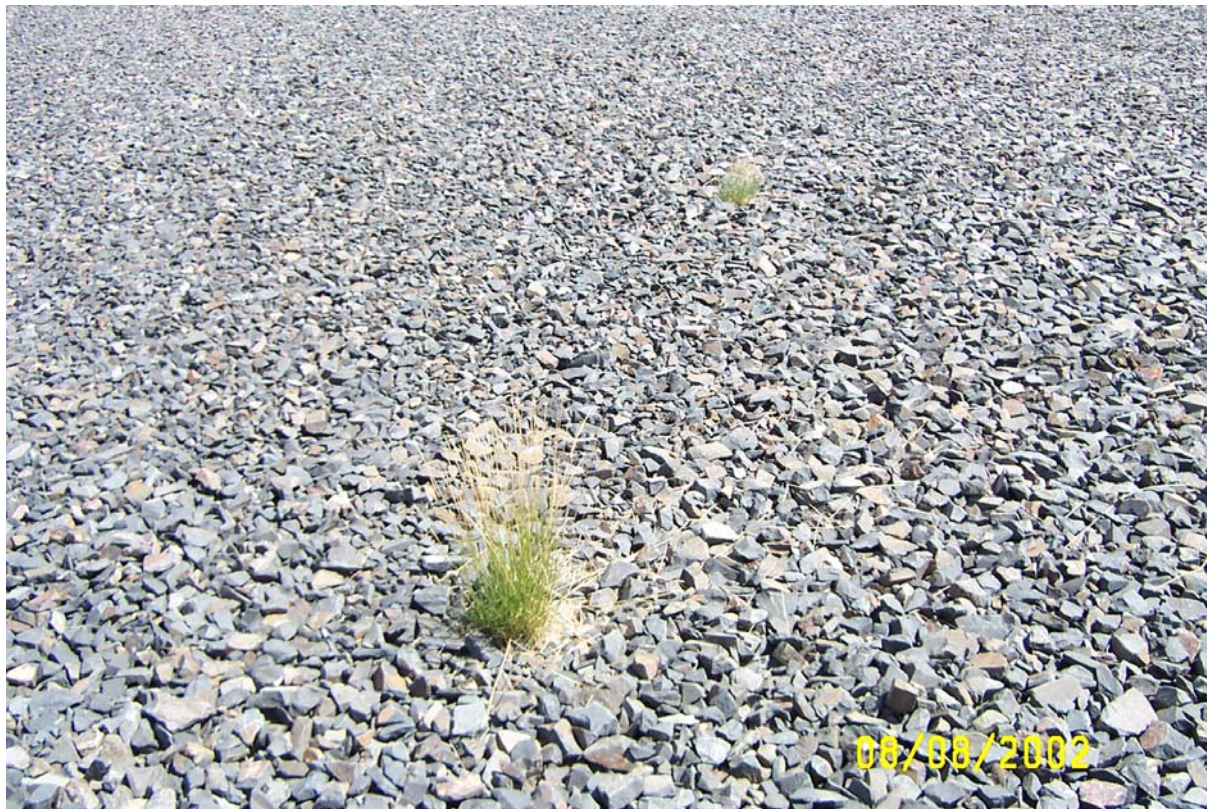
Top of Disposal Cell—The top of the disposal cell was in excellent condition. There was no evidence of erosion, settling, or slumping. A few isolated patches of grass were observed on the disposal cell cover; however, these plants do not present a hazard or cause for concern at this time (PL-1).

PL-1. Patch of grass on top of cell.

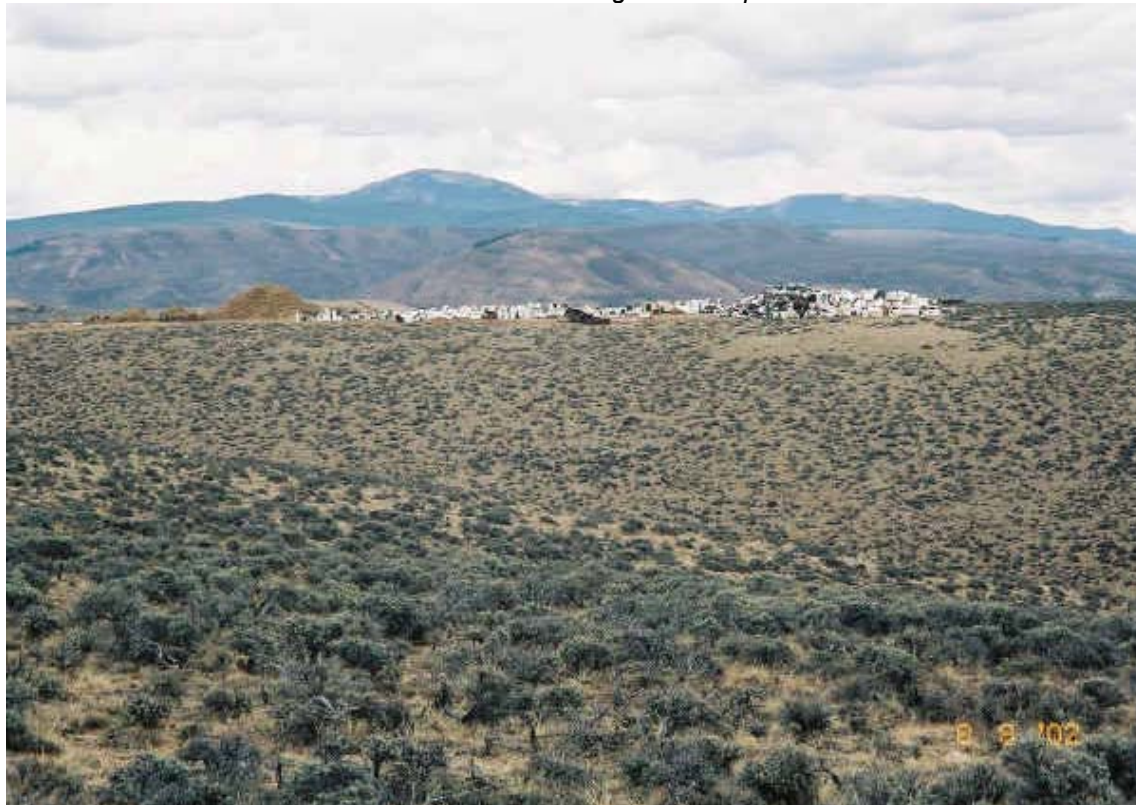
At the time of the inspection, no active land filling operations had occurred within 0.25 mile of the disposal site. The nearest active portion of the landfill is located approximately 0.75 mile northeast of the disposal site. An appliance disposal area opened in 2001, but it poses no threat to the DOE disposal site (PL-2). No other evidence of activity was noted near the site boundary.

PL-2. View of appliance scrap/disposal area at Gunnison County landfill.

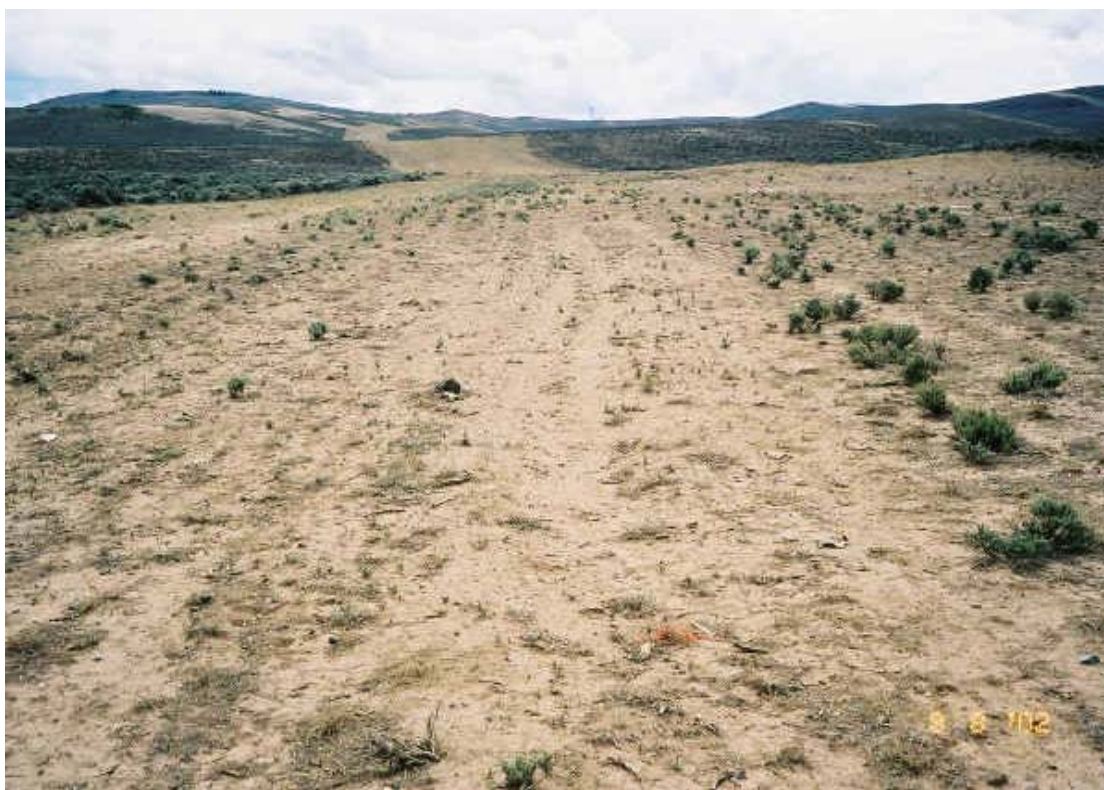
Inspectors assessed revegetation success at several sites along the former Chance Gulch and Tenderfoot Mountain haul roads. The former Chance Gulch haul road is approximately 0.25 mile west of the disposal cell, and the former Tenderfoot Mountain haul road extends from the disposal cell westward to the former processing site. A U.S. Bureau of Land Management right-of-way permit requires successful revegetation of both haul roads. Several areas along the haul roads were reseeded in October 2000 to meet U.S. Bureau of Land Management's vegetation success criteria for species diversity. Vegetative cover in the reseeded areas was sparse and composed primarily of two annual weeds, Russian thistle and kochia (PL-3 through PL-5). Because the Gunnison area experienced severe drought conditions during 2002, the reseeded areas had not improved since the last inspection. The success of reestablishing vegetation in these areas will continue to be monitored.

PL-3. Chance Gulch reseeded area; looking south at second patch from road.

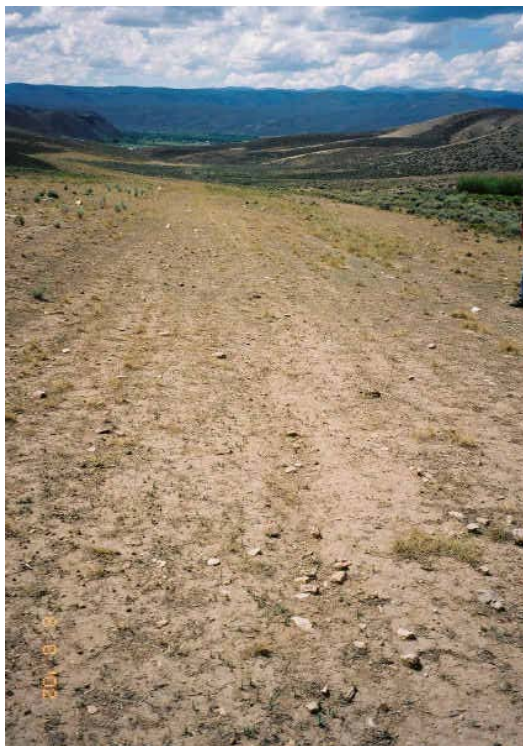
PL-4. Tenderfoot Mountain haul road; looking north at Reseed Area 3.

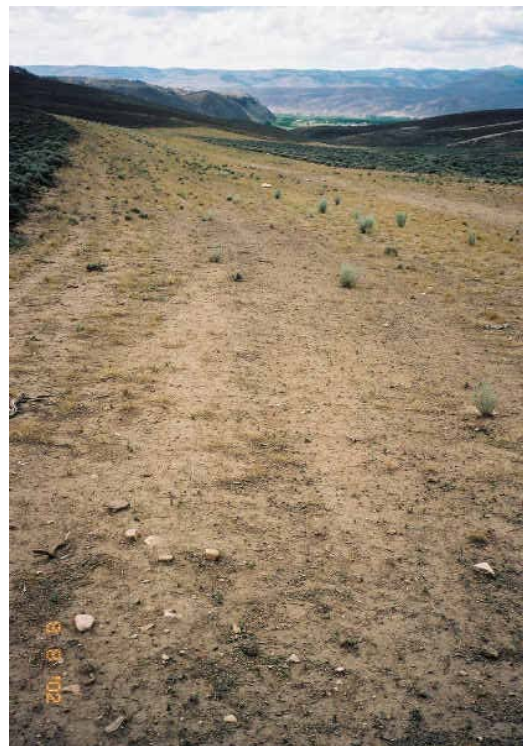
PL-5. Tenderfoot Mountain haul road; looking north at Reseed Area 2.
